COMBUSTION TURBINE (CT) HOT SECTION COATING LIFE MANAGEMENT

Semi Annual Technical Progress Report

***Agreement Number:* DE-FC26-01NT41231**

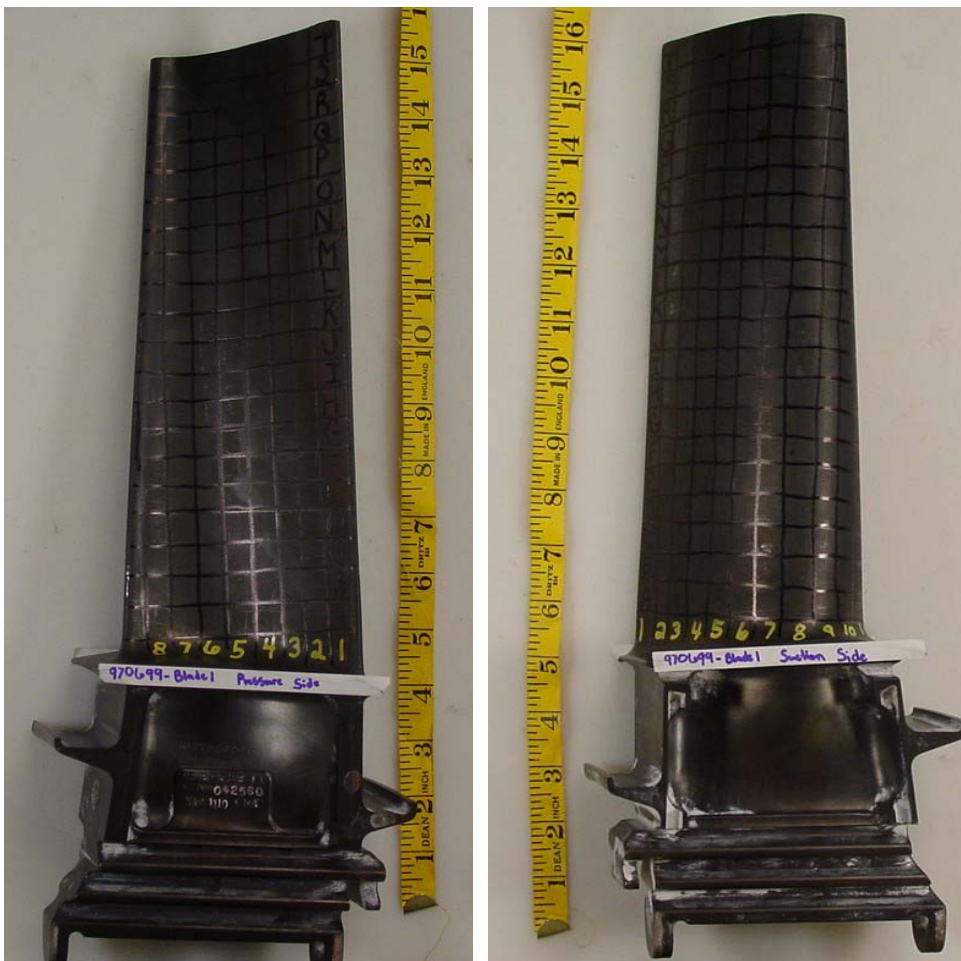
Figure 6-1. Details of grid marks from pressure and suction sides of the 2nd stage bucket coated with GT 33+ coating

Figure 6-1 shows an overall layout of the inspected 2nd stage bucket that has been gridded out for eddy current measurements.

As shown in the figure, each grid box was approximately ½-inch square with alpha- numeric designation. The alphabets increased 1 through 20 (A-T) from the platform to blade tip, while the numbers increased (1-11 and 1-8) along the chord from the trailing edge to leading edge on the suction and pressure side of the blade, respectively, as shown. The number of maximum scans along the blade height was 20 scans from the chord positions #1 through 7, while the number dropped to 9 scans at chord position #8 on the pressure side. On the suction side, 20 scans were obtained from chord positions #1-8, 18 scans from chord position #9, 10 scans from chord position #10, and 3 scans from chord position #11.

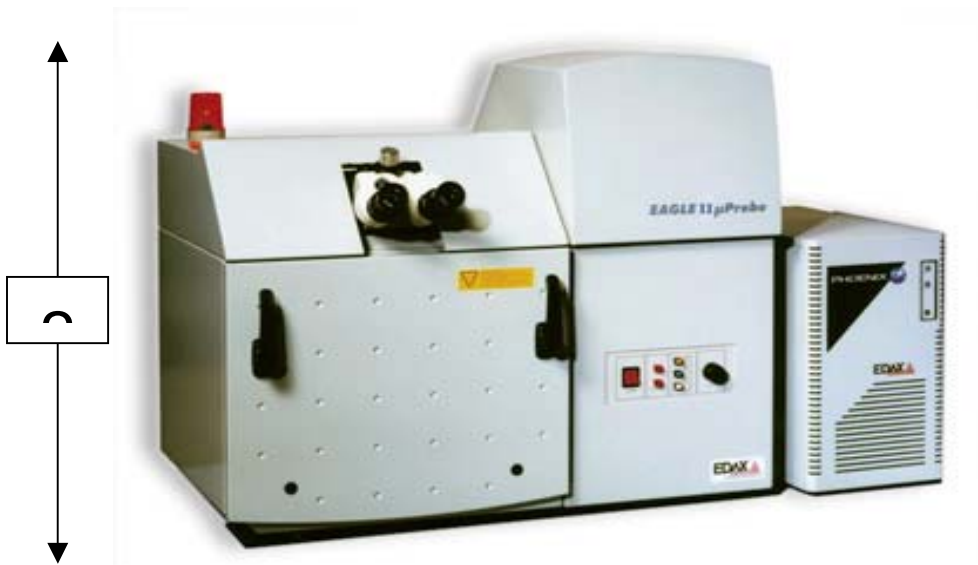
Figure 6-8. EDAX Eagle II X-Ray Florescence System

transitions terminating in the K shell are known as "aK" x-rays, and x-rays resulting from the most probable transitions terminating in the L shell are known as "aL" x-rays. Fluorescence occurring due to direct excitation by x-rays from the x-ray source is known as "primary fluorescence". Fluorescence from an atom excited by x-rays fluoresced from the other elements in the sample is known as "secondary fluorescence". For this testing, fluoresced x-ray energies and rates are measured with a solid-state energy-dispersive detector. The energies of these emitted x-rays are used to identify the elements present in the sample while the concentrations of the elements are determined by the intensity of the x-rays. With proper calibration, the various elements present and their concentrations can be determined. What was attempted involved testing and comparison of results obtained from an as-coated test specimen to those thermally aged test samples using a portable XRF system shown as Figure 6-8.
